## INVITATION FOR BIDS

The Bear River Band of the Rohnerville Rancheria (herein called the Owner) will receive bids for **“BRB-Earthquake Damage Repairs-DR4692”**. Bids are due October 15, 2026 delivered to the Tribes representative outlined in this Invitation for Bids.

### **Project No. 714343 – Water Treatment Facility**

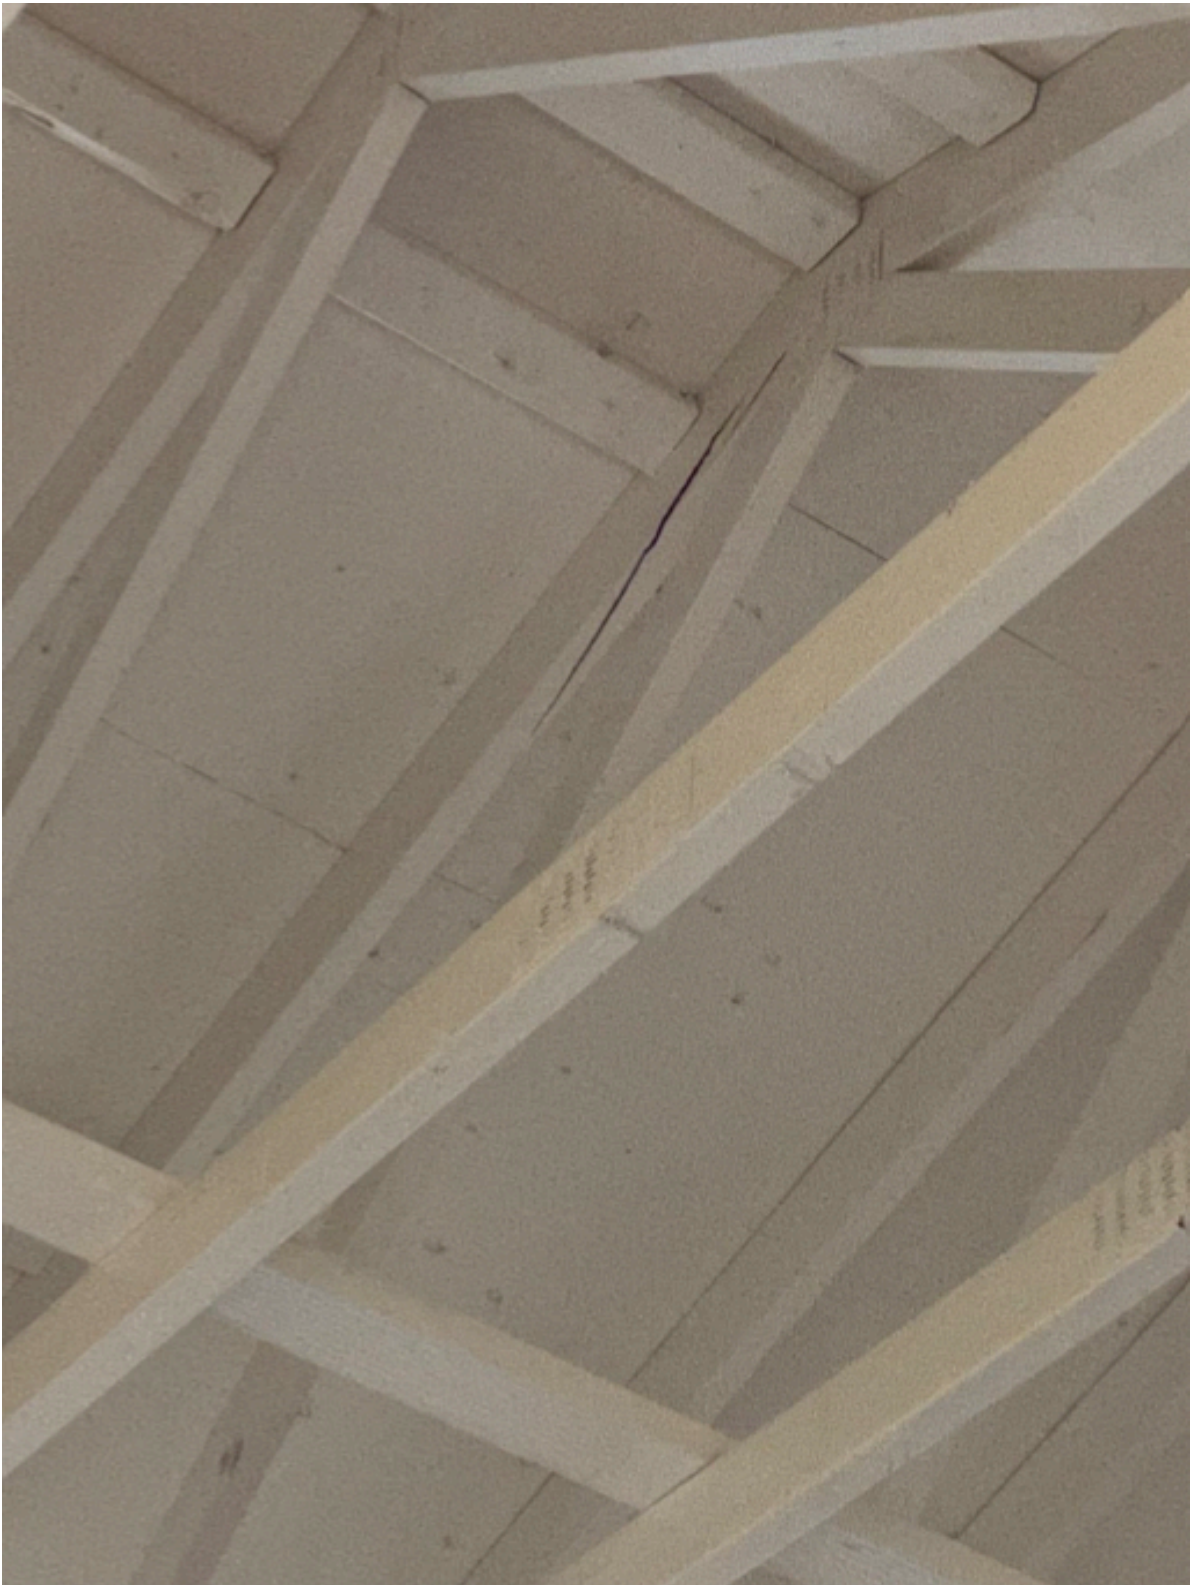
- a) **Building Exterior:** 8 each of hairline cracks that run from the floor to ceiling along a CMU Wall. Each crack is 12 FT long. The building footprint measures 54 FT long x 27FT wide. The CMU walls are 12FT high. The Concrete Masonry Unit blocks are 16IN wide x 8 IN high x 8 IN deep. Cracks occurred throughout the CMU walls and are visible on the interior and exterior of the building, also causing damage to the interior paint.
- b) **Building Interior:** 8 each of hairline cracks that run from the floor to ceiling along CMU wall will be painted to match existing interior paint. Painting will be along each crack at 12FT long. The interior paint was damaged due to cracks that occurred during the earthquake
- c) Cracking in roof trusses/chords member.

Photo Water Treatment Facility - Broken Chord Member

- 1) Repair 8 each of hairline cracks of CMU Wall, 12 FT long each crack
- 2) Paint to match all areas.
- 3) Sistering of Joints with detail approved by a licensed engineer.
